# SAMPLE PROPERTY ADDRESS

Professional Snagging Inspection

Property Inspection Perth

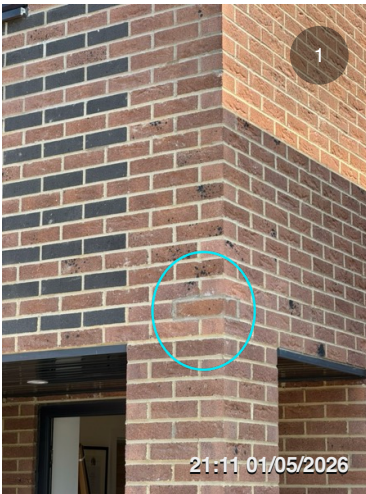
### Issue 1

Mortar is discoloured - please replace.

Issue appears inconsistent with the WA Guide to Standards and Tolerances relating to acceptable brickwork appearance and mortar finish.

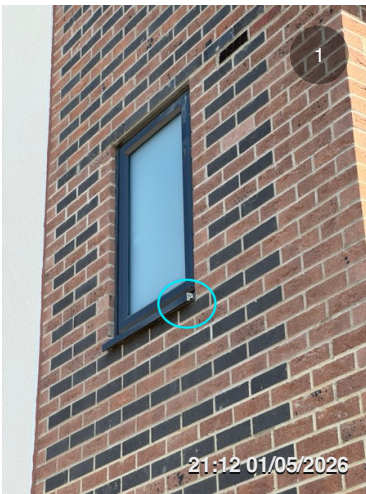
### Issue 2

Window sill end cap missing - please install.

Issue appears inconsistent with manufacturer installation requirements relating to external window sill components.

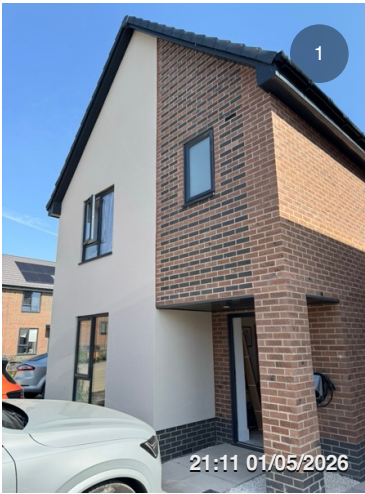
### Issue 3

Brick clean required to remove mortar staining from all Elevations.

Issue appears inconsistent with acceptable completion and presentation standards. Professional clean required to remove staining and construction residue.

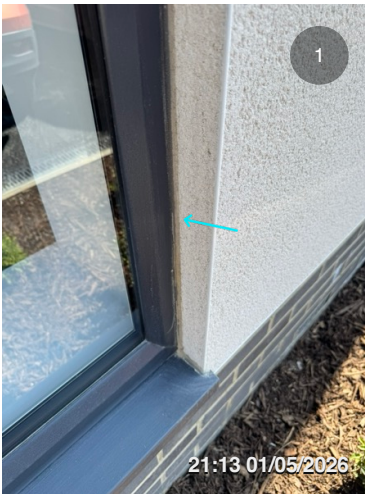
### Issue 4

Poor sealant application - attention required to improve.

Issue appears inconsistent with acceptable sealant finish standards and manufacturer installation requirements.

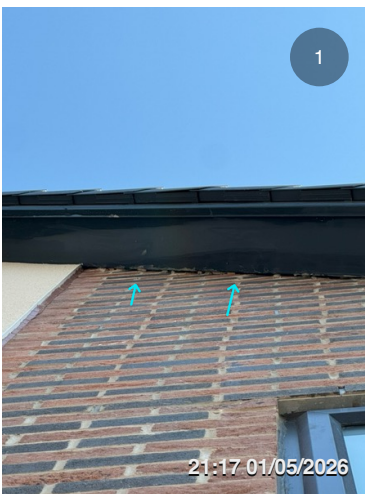
### Issue 5

Gap between soffit and brickwork finish - please improve for aesthetical purposes.

Issue appears inconsistent with the WA Guide to Standards and Tolerances relating to acceptable external finish quality and workmanship.

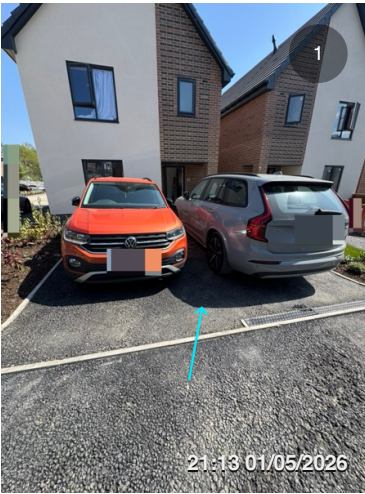
## Issue 6

Wearing course installation date should be confirmed in accordance with contractual completion requirements.

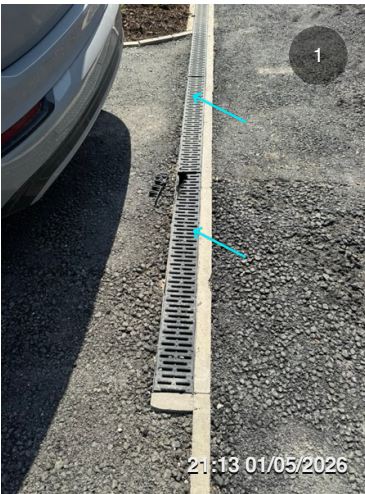
## Issue 7

Damage to ACO drain channel - please replace.

Issue appears inconsistent with the WA Guide to Standards and Tolerances relating to external works and drainage components.

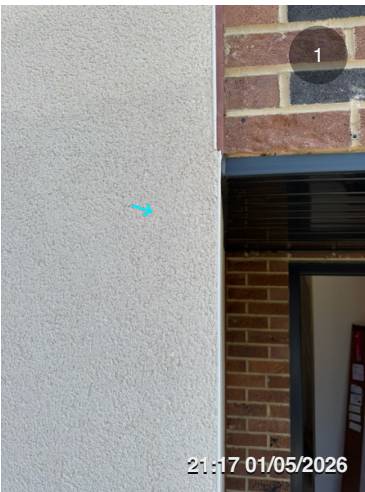
## Issue 8

Cracking to the render finish appears inconsistent with acceptable external wall finish standards.

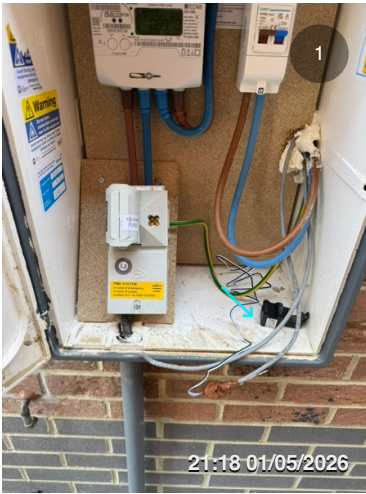
## Issue 10

Penetrations should be adequately sealed to reduce the risk of moisture ingress, pest entry and air leakage in accordance with NCC weatherproofing requirements.

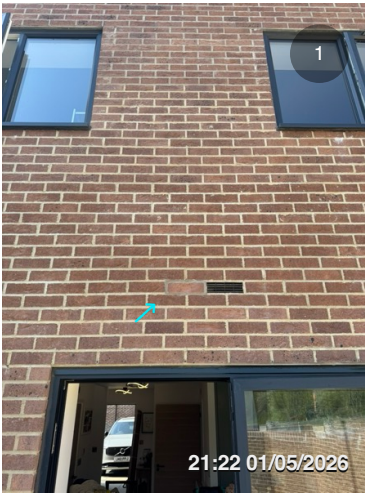
## Issue 12

Mortar is discoloured - please improve.

Issue appears inconsistent with the WA Guide to Standards and Tolerances relating to acceptable brickwork appearance and mortar finish.

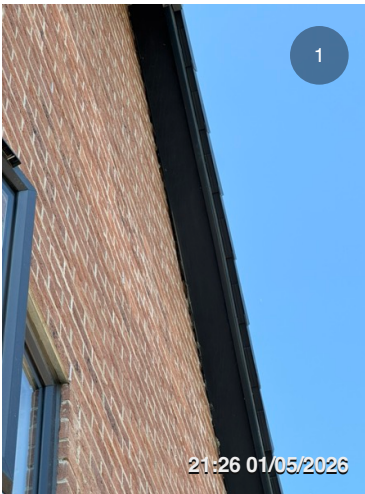
## Issue 13

Gap between soffit and brickwork - please improve for aesthetical purposes.

Issue appears inconsistent with the WA Guide to Standards and Tolerances relating to acceptable external finish tolerances and workmanship.

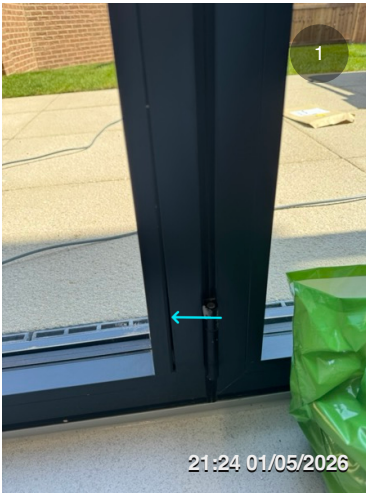
### Issue 15

Window beading should be securely fixed in accordance with manufacturer installation requirements.

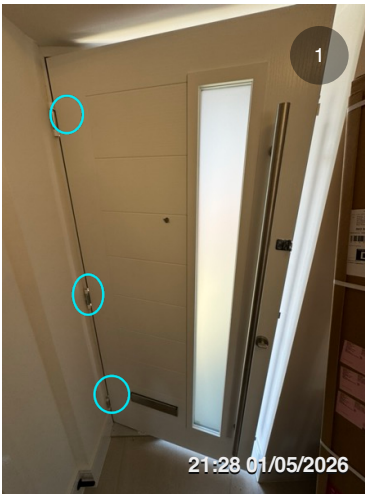
### Issue 18

Missing hinge caps - please install.

Door hardware components are incomplete and should be installed accordingly.

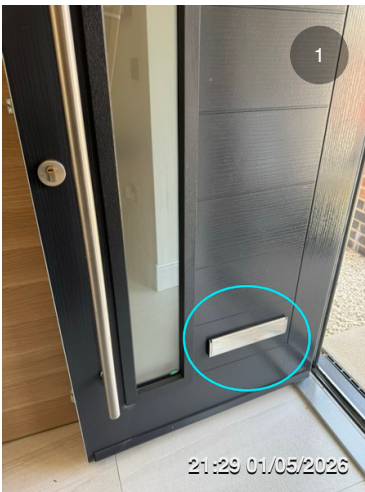
### Issue 19

Letterbox height should comply with NCC accessibility provisions relating to accessible use and operation.

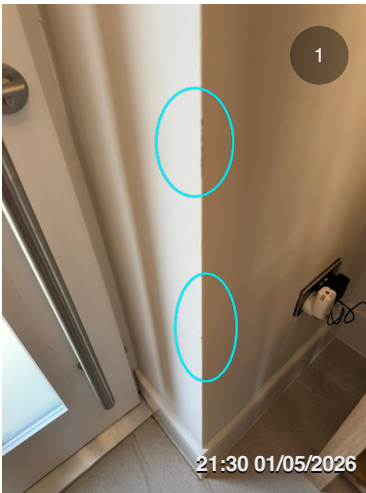
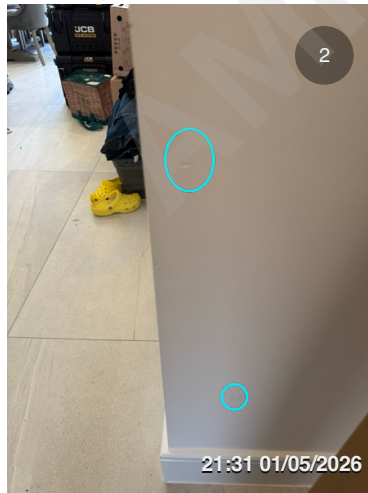
## Issue 21

Poor wall finishes - attention required to improve.

Issue appears inconsistent with the WA Guide to Standards and Tolerances relating to acceptable wall finish quality.

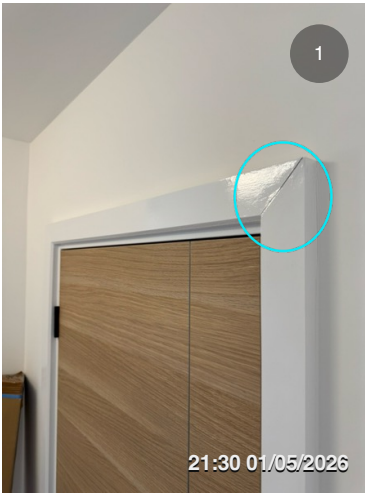
## Issue 22

Shrinkage cracks forming - please repair.

Issue appears inconsistent with the WA Guide to Standards and Tolerances relating to acceptable paint finish and shrinkage cracking.

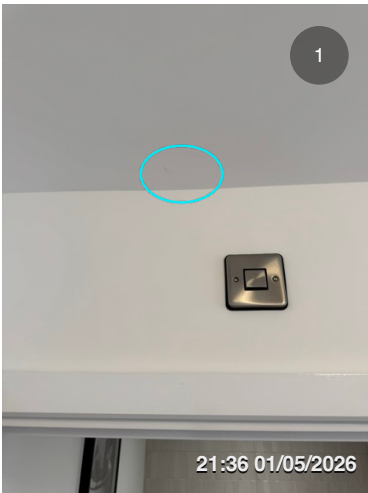
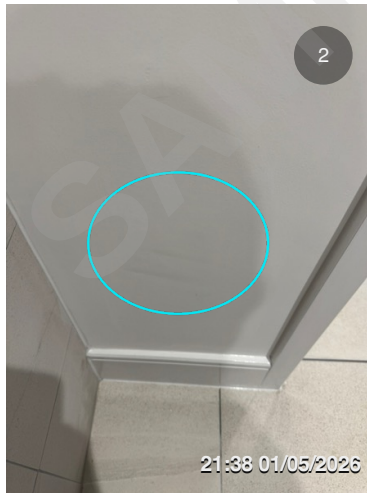
### Issue 23

Poor wall finishes - attention required to improve.

Issue appears inconsistent with the WA Guide to Standards and Tolerances relating to acceptable wall finish quality.

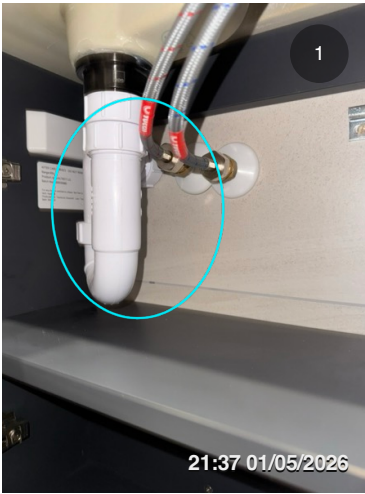
## Issue 24 ⚠

Leak detected from waste pipes - please repair.

Issue appears inconsistent with AS/NZS 3500 Plumbing and Drainage standards relating to sanitary fixture connections.

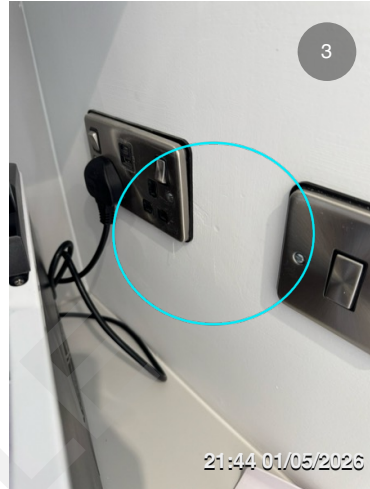
## Issue 27

Poor wall finishes - attention required to improve.

Issue appears inconsistent with the WA Guide to Standards and Tolerances relating to acceptable wall finish quality.

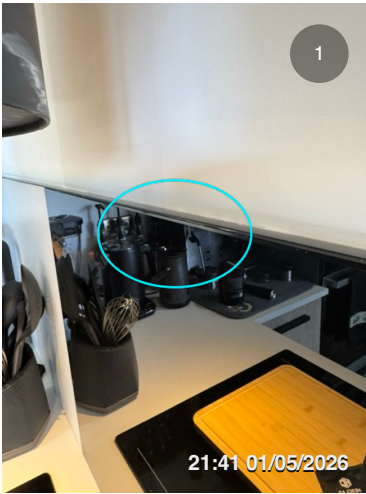
## Issue 28

Please remove over paint from the back splash.

Issue appears inconsistent with acceptable completion and presentation standards.

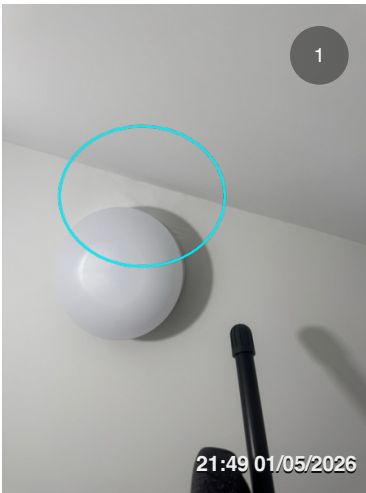
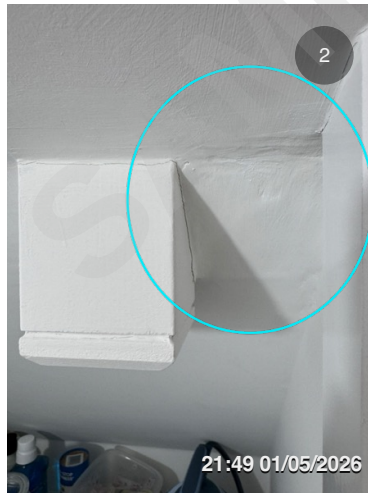
### Issue 29

Poor wall finish - attention required to improve.

Issue appears inconsistent with the WA Guide to Standards and Tolerances relating to acceptable wall finish quality.

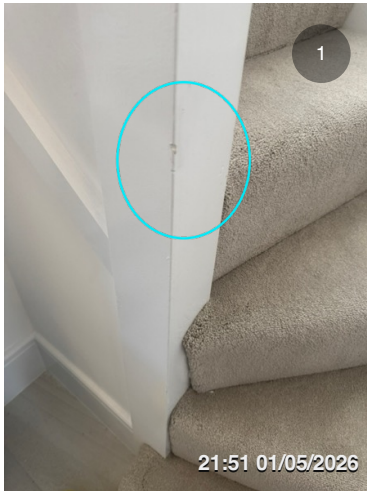
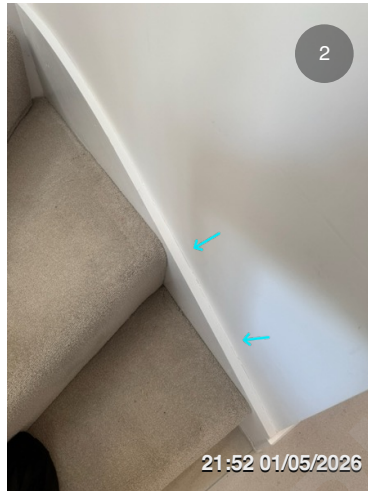
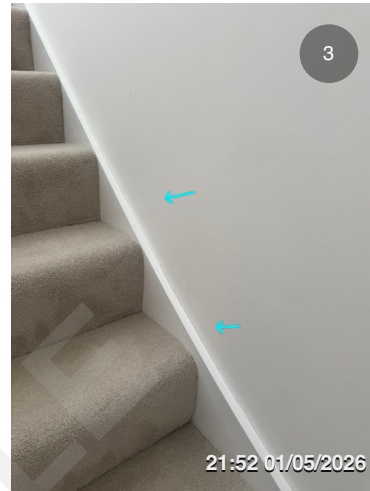
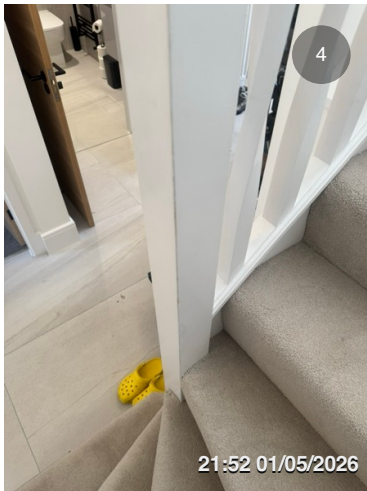
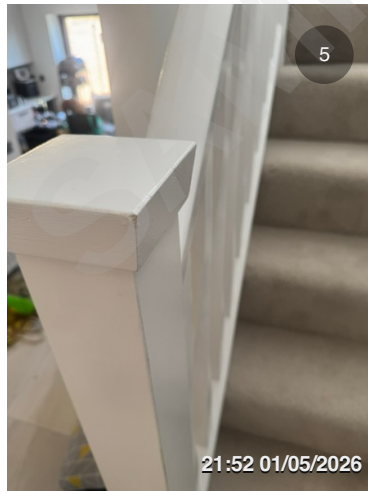
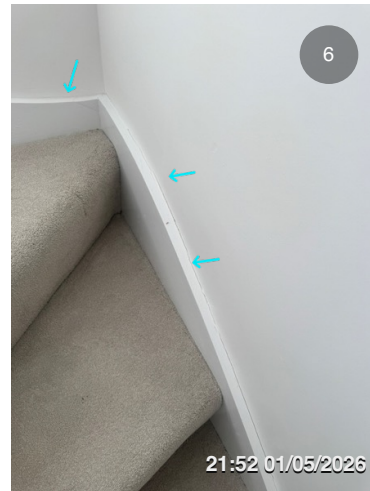
## Issue 30

Poor paint finishes and shrinkage cracks - please improve.

Issue appears inconsistent with the WA Guide to Standards and Tolerances relating to paint finish and shrinkage cracking.

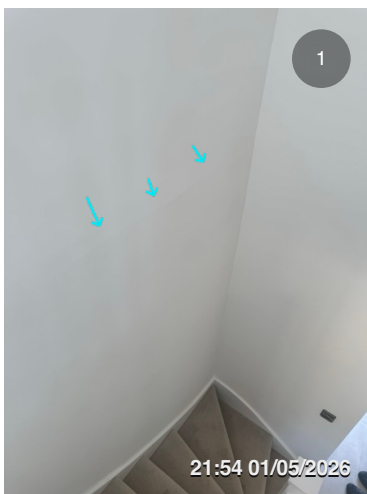
## Issue 31

Poor wall finishes - attention required to improve.

Issue appears inconsistent with the WA Guide to Standards and Tolerances relating to acceptable wall finish quality.

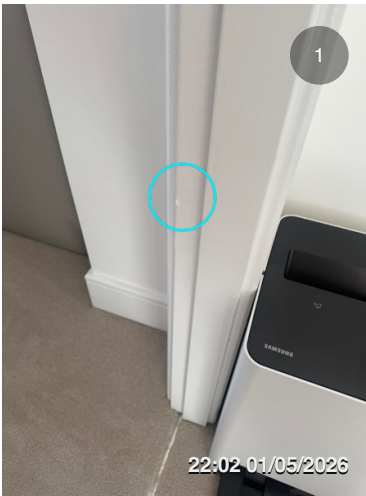
## Issue 34

Indentation to the woodwork - please improve.

Issue appears inconsistent with the WA Guide to Standards and Tolerances relating to finish quality.

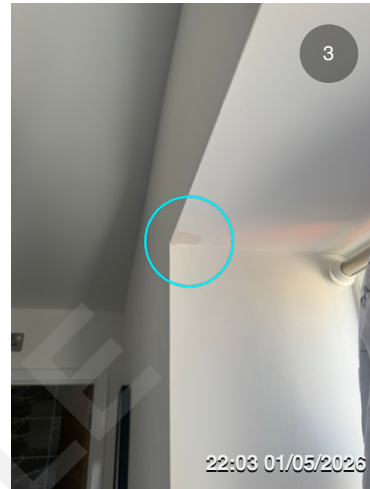
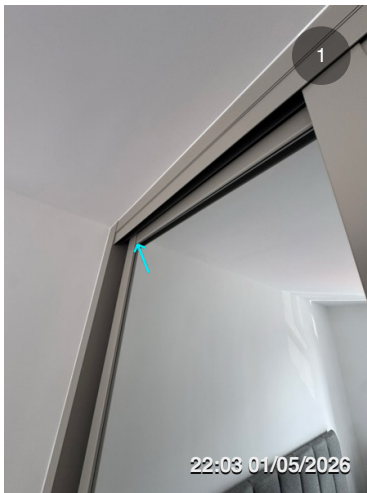
## Issue 35

Poor wall finishes - attention required to improve.

Issue appears inconsistent with the WA Guide to Standards and Tolerances relating to acceptable wall finish quality.

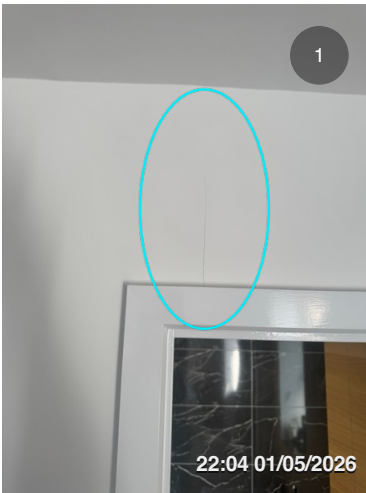
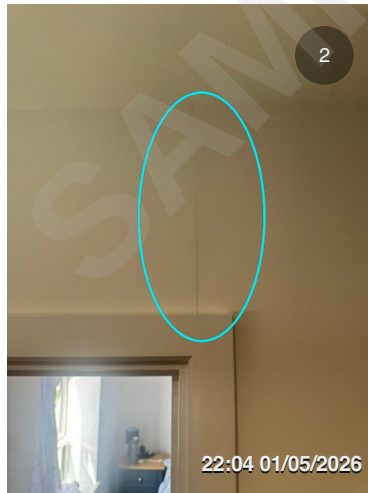
### Issue 37

Cracking appearing on the wall above door - please repair.

Issue appears inconsistent with the WA Guide to Standards and Tolerances relating to shrinkage cracking and wall finish presentation.

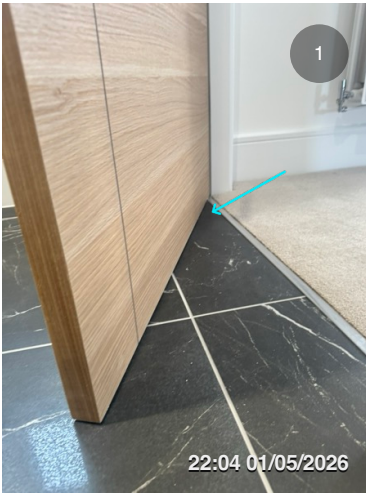
### Issue 38

Door is binding against the carpet threshold and requires adjustments.

Issue appears inconsistent with acceptable door operation and clearance tolerances.

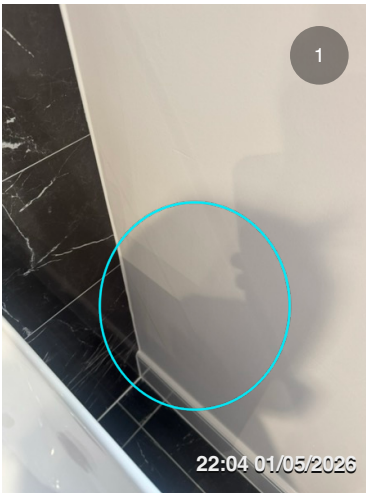
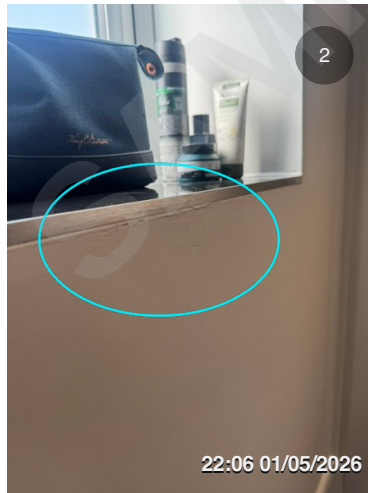
### Issue 39

Poor wall finishes - attention required to improve.

Issue appears inconsistent with the WA Guide to Standards and Tolerances relating to acceptable wall finish quality.

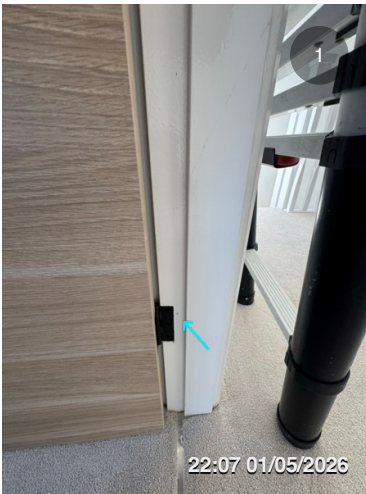
## Issue 42

Poor paint finish to door frame - please improve.

Issue appears inconsistent with the WA Guide to Standards and Tolerances relating to acceptable paint finish quality.

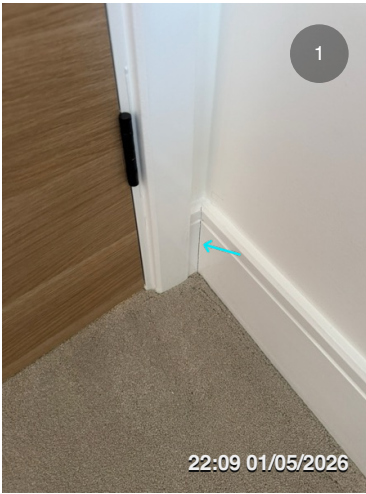
#### Issue 44

6mm gap present.

The gap between the door and head or jamb should be a maximum of 4mm (for double doors, the gap at the meeting stiles should be within 4mm) and uniform - please rectify this issue.

Issue appears inconsistent with acceptable door fitment and alignment tolerances.

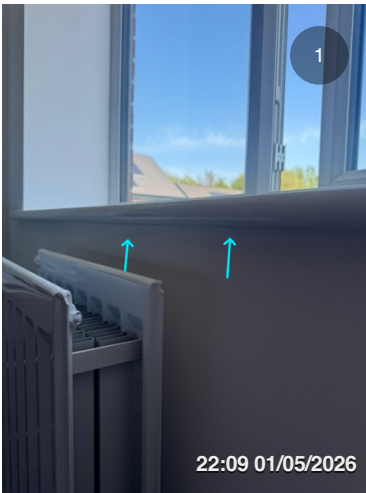
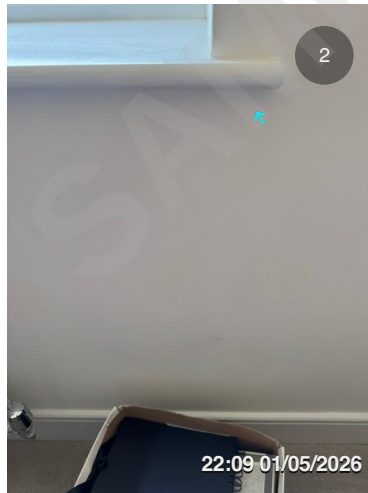
### Issue 46

Please improve the quality of wall finish around the window board.

Issue appears inconsistent with the WA Guide to Standards and Tolerances relating to acceptable wall finish presentation.

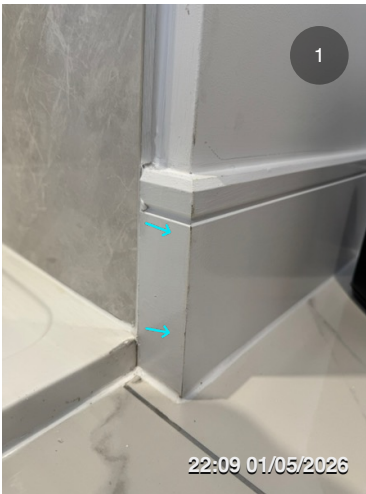
### Issue 47

Poor paint finish - please improve.

Issue appears inconsistent with the WA Guide to Standards and Tolerances relating to acceptable paint finish quality.

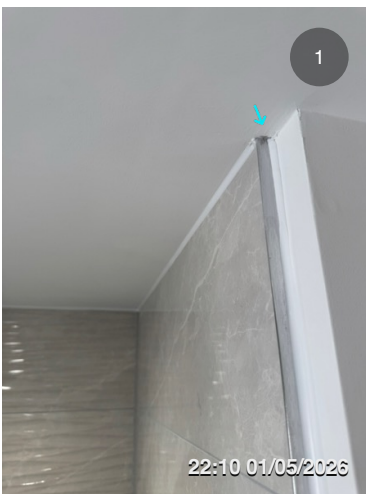
### Issue 48

Poor paint finishes - attention required to improve.

Issue appears inconsistent with the WA Guide to Standards and Tolerances relating to paint finish consistency.
