# SAMPLE PROPERTY ADDRESS

Professional Snagging Inspection

Property Inspection Perth

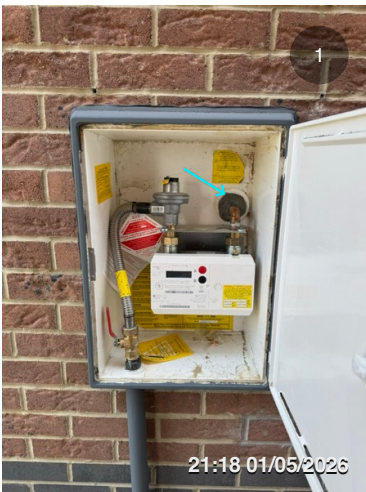
## Issue 9

No equipotential bonding present to gas main inlet.

Electrical bonding installation should be confirmed in accordance with AS/NZS 3000 Wiring Rules.

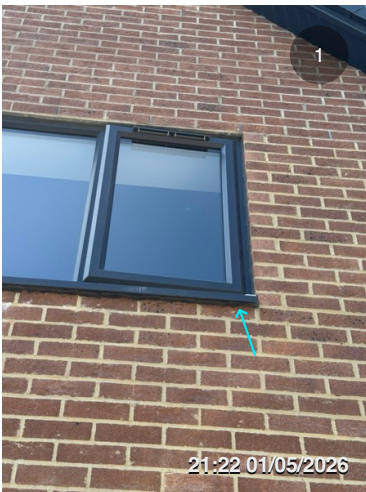
## Issue 11

Protective film should be removed prior to handover in accordance with acceptable completion standards.

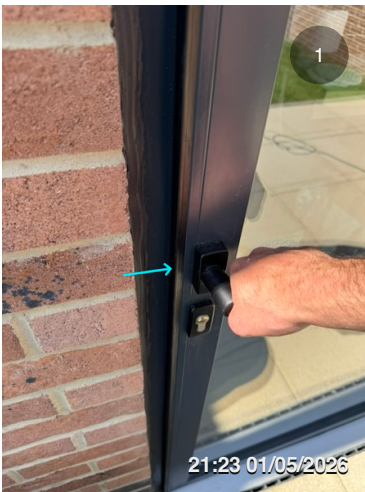
## Issue 14

Door is difficult to operate - please adjust accordingly to improve and ease operation.

Door operation should be adjusted to ensure satisfactory operation in accordance with manufacturer installation requirements.

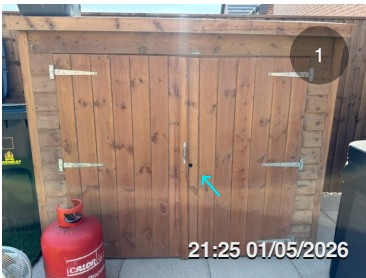
### Issue 16

Shed doors should be adjusted to ensure satisfactory operation and alignment.

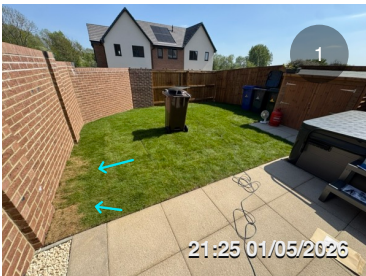
### Issue 17

Landscaping should be completed to an acceptable condition prior to handover.

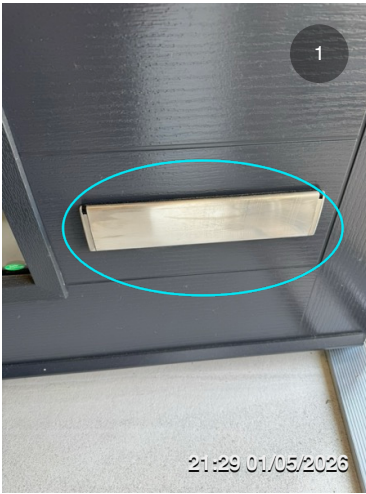
## Issue 20

Construction residue should be removed prior to practical completion.

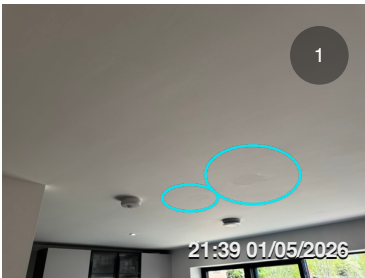
### Issue 25

Inconsistent paint finish to the ceiling - attention required to improve.

Issue appears inconsistent with the WA Guide to Standards and Tolerances relating to paint finish consistency.

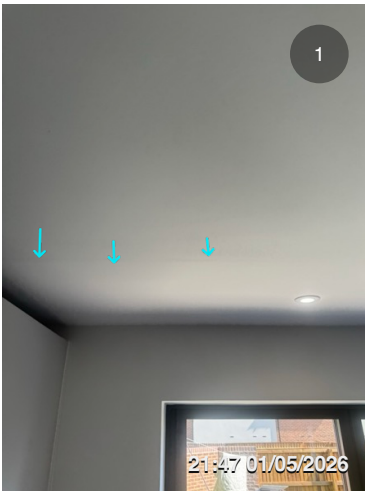
### Issue 26

Poor wall finishes - attention required to improve.

Issue appears inconsistent with the WA Guide to Standards and Tolerances relating to acceptable wall finish quality.

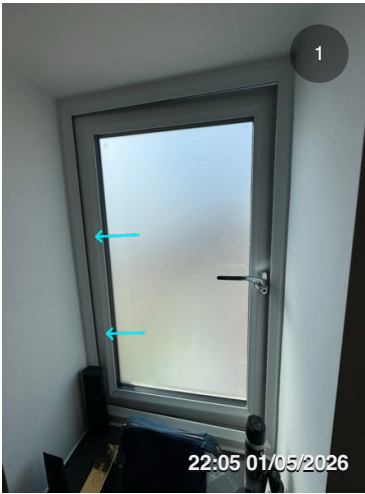
#### Issue 40

Window sash is binding against the frame and is difficult to operate - please adjust accordingly to improve and ease operation.

Issue appears inconsistent with manufacturer installation requirements relating to satisfactory window operation.

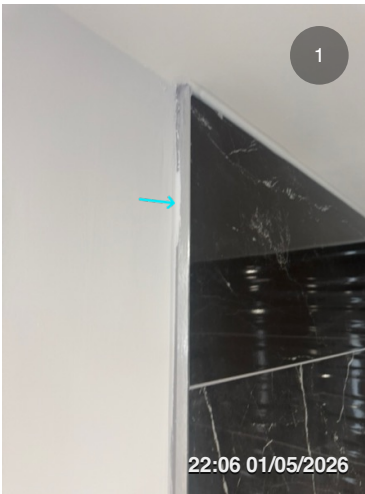
#### Issue 41

Please remove excess paint from the tile trim.

Issue appears inconsistent with acceptable completion and paint finish standards.

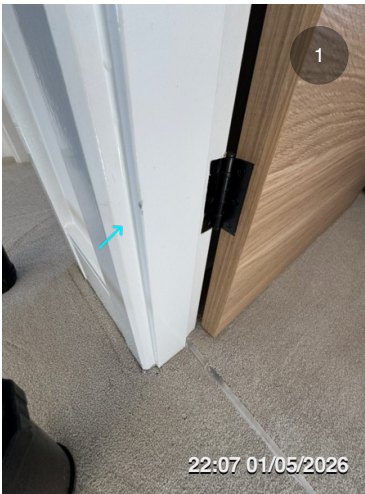
#### Issue 43

Poor paint finishes to door frame - attention required to improve.

Issue appears inconsistent with the WA Guide to Standards and Tolerances relating to acceptable paint finish quality.
